UPDATED CAPITAL RESERVE ANALYSIS
FOR
AVOCET NEIGHBORHOOD
NORCROSS, GEORGIA

PREPARED BY: STEVEN W. RAY, P.E.

JUNE 2011

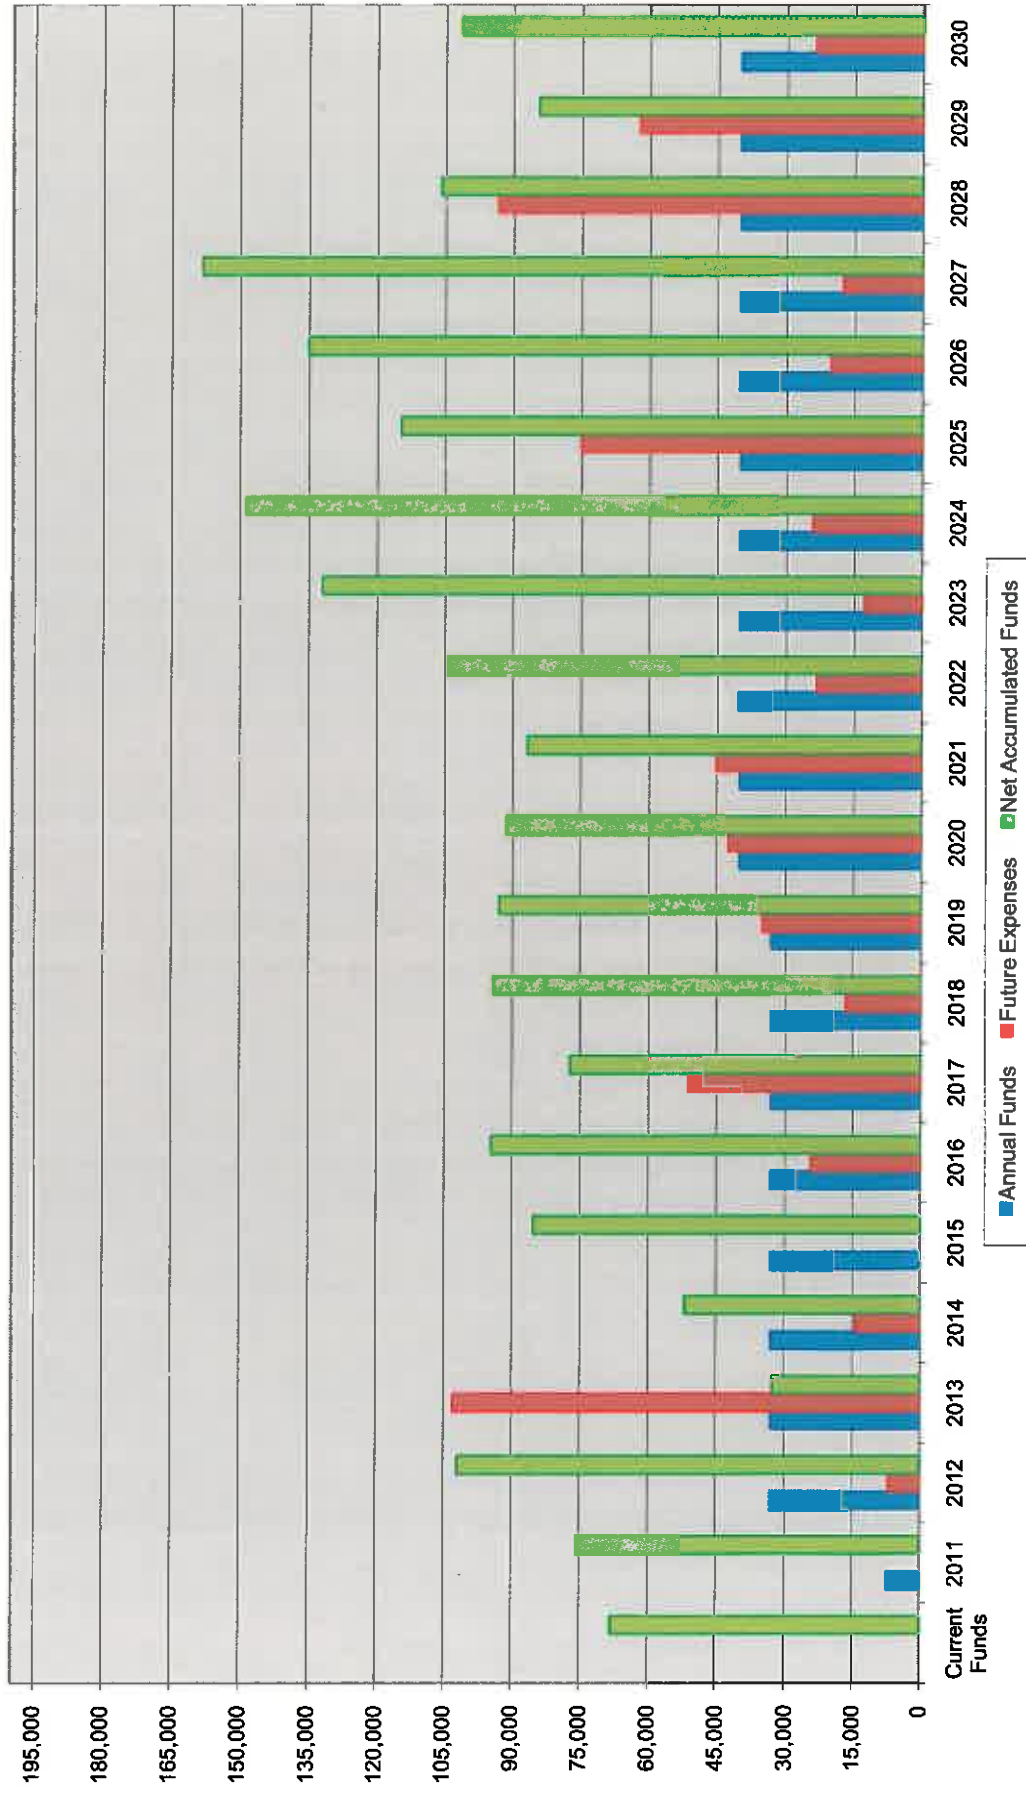
AVOCET - PROJECTED CASH FLOW

The projected cash flow for the Capital Reserve Analysis is illustrated by the bar graph and line chart on the following pages.
